1. REPORT DATE  JAN 2008		2. REPORT TYPE		3. DATES COVE 00-00-2008	RED 8 to 00-00-2008
4. TITLE AND SUBTITLE				5a. CONTRACT	NUMBER
Performance Evaluation Test of the Peco Tracked Brush I			Blazer	Sb. GRANT NUMBER	
				5c. PROGRAM E	ELEMENT NUMBER

**Report Documentation Page**

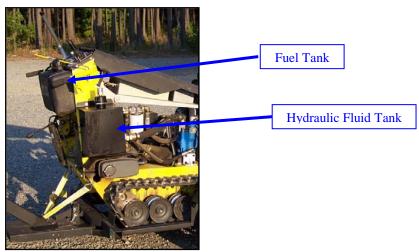
Figure 27: Fuel and Hydraulic Fluid Tanks

Fluids and fuel were checked and refilled daily before operations or as needed. The Peco Cutter uses unleaded gasoline and is equipped with a 5 (U.S.) gallon (18.9 liter) tank. The hydraulic fluid tank capacity is approximately 2.5 (U.S.) gallons (9.5 liters). Both the fuel and hydraulic tanks are located at the rear of the Peco Cutter (see Figure 27).
